# SERVICE BULLETIN

## INSPECTION OR REPLACEMENT OF THE ROCKER ARMS AND VALVE PUSH-RODS FOR ROTAX® ENGINE TYPE 912 AND 914 (SERIES)

SB-912-035 R1

SB-914-021 R1

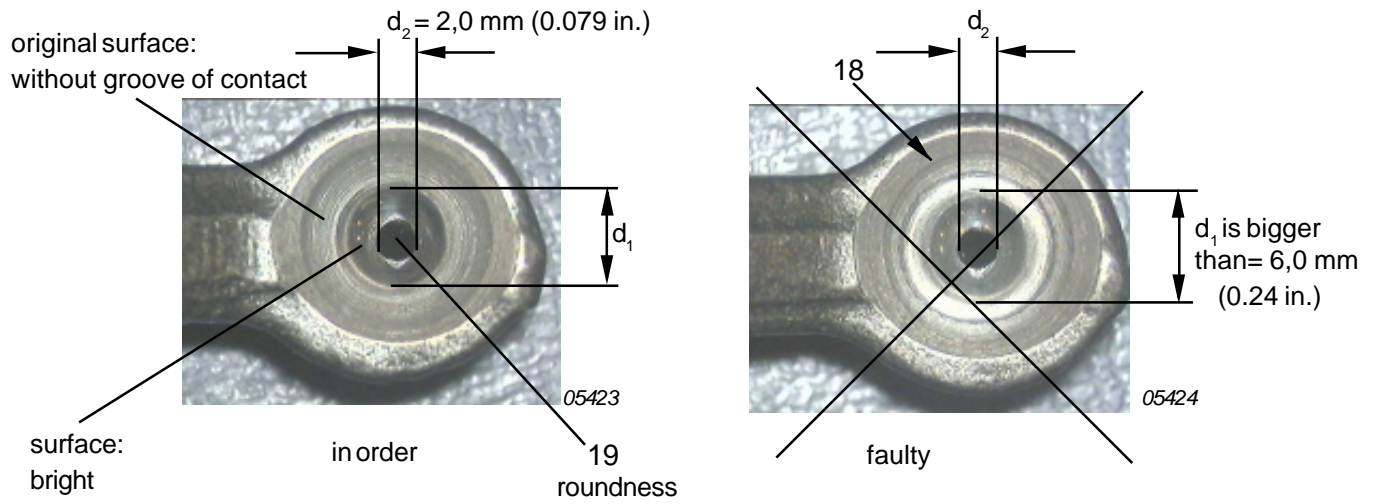
**fig. 3**  
05122

- Visually inspect all rocker arms and push-rods for damage or wear and tear. You may reuse the parts, provided that the accomplishment of the instructions of rocker arms and push-rod did not substantiate damages or traces of wear.

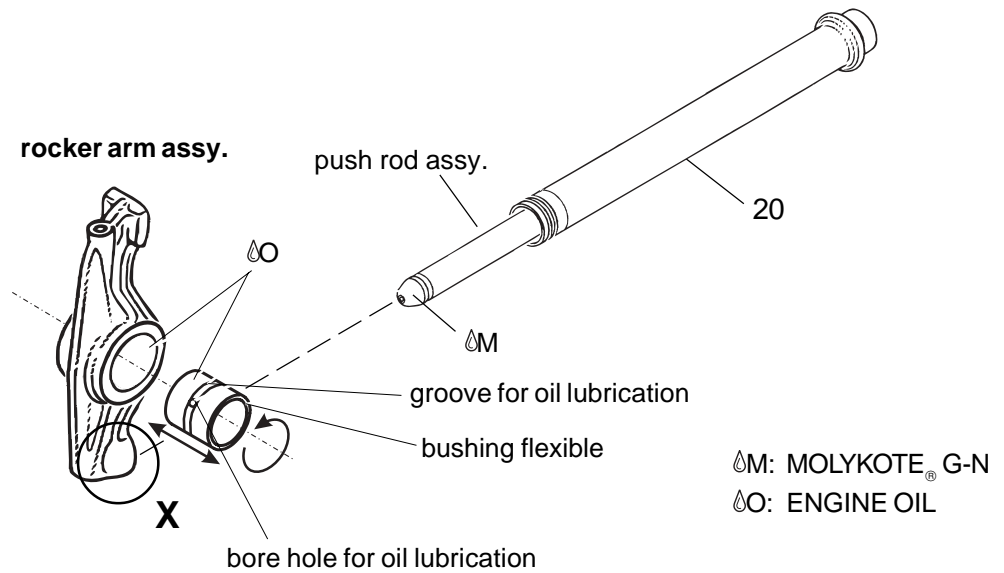
**fig. 4** **Detail X**

◆ **NOTE:** Detailed visual inspection particularly in the rocker arm ball joint (female) area.  
See fig. 4.

- Inspect rocker arm ball joint (female) (18). Traces of wear on the rocker arms are noticeable by geometric changes of the spherical form and smoothed areas in the ball joint shine brightly. Should the engine not have been running for more than one month, then the shining part may become dull again. The diameter of the smoothed running surface, measured by a sliding caliper (or equivalent) along the rocker arm axis, shall not exceed a value of  $d_1=6,0$  mm (0.24 in.). Inspect lubricating bore (19)  $d_2= 2,0$  mm (0.079 in.) for roundness. The roundness tolerance must lie within 0,2 mm (0.0079 in.). Any tendency towards an oblong hole is not permissible.

- Should one of these criteria be encountered, replace the appropriate rocker arm **and** its associated push-rod.

▲ **WARNING:** Should damages or traces of wear be discovered on the rocker arms or push-rods, you will need to replace them immediately.
