Emergency Airworthiness Directive

AD No.: 2018-0265R1

ATA 72 – Engine – Exhaust Valve – Replacement

Exchange of exhaust valves on ROTAX® Engine Types 915 i A, 915 i B (Series) and 914 (Series)

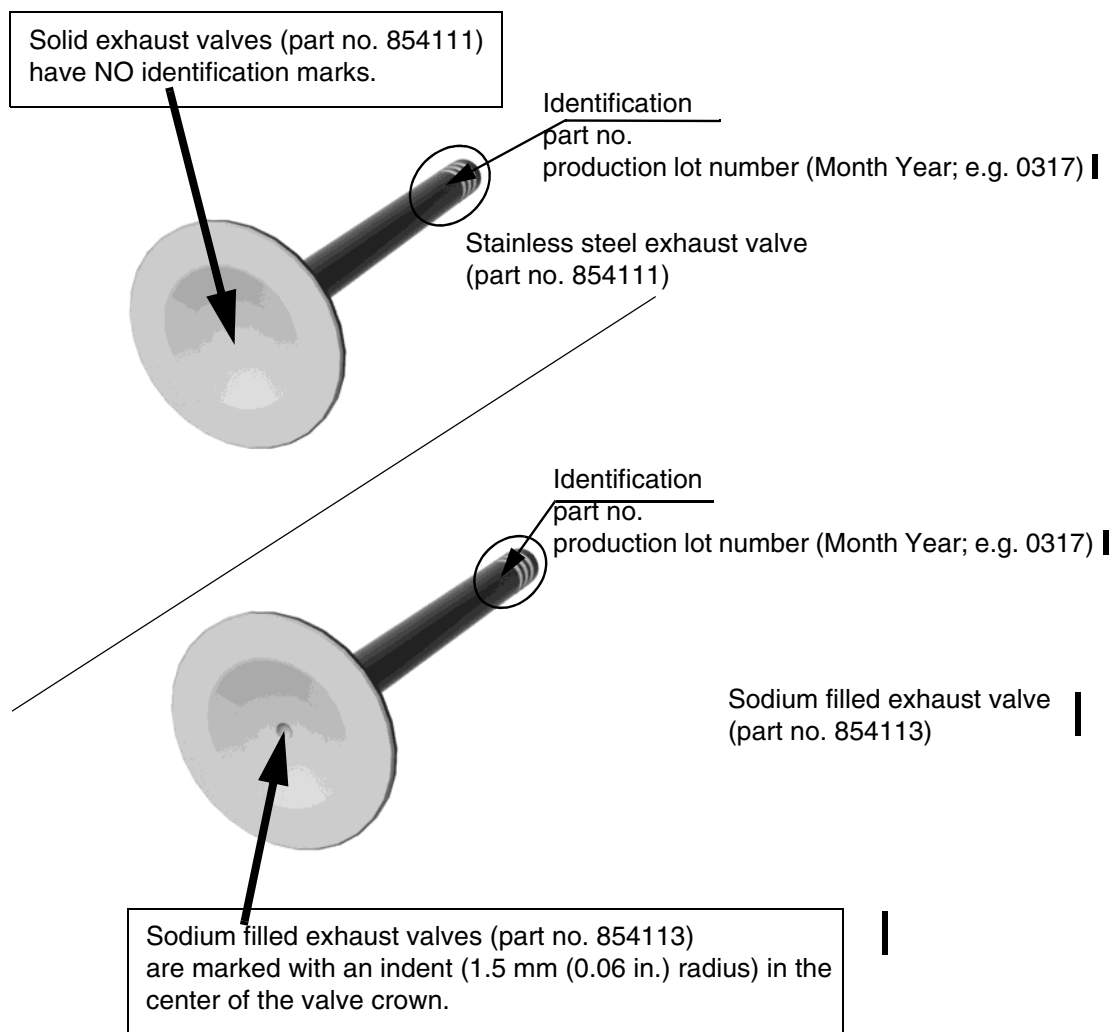
Fig. 2
Identification of exhaust valves

The engines below have been fitted by the manufacturer with an exhaust valve 32 mm (1.26 in.) part no. 854113 with a variety of production lots from which the production lot numbers 0317 and 0517 (see Fig. 2) are affected.

All engines are affected, which have been equipped with an exhaust valve 32 mm (1.26 in.) with part no. 854113 with a production lot number 0317 and 0517 during engine repair, maintenance or general overhaul (see Fig. 2).
