SERVICE BULLETIN

CHECKING OF THE CRANKCASE

ON ROTAX® ENGINE TYPE 912 AND 914 (SERIES)

SB-912-029 R2
SB-914-018 R2

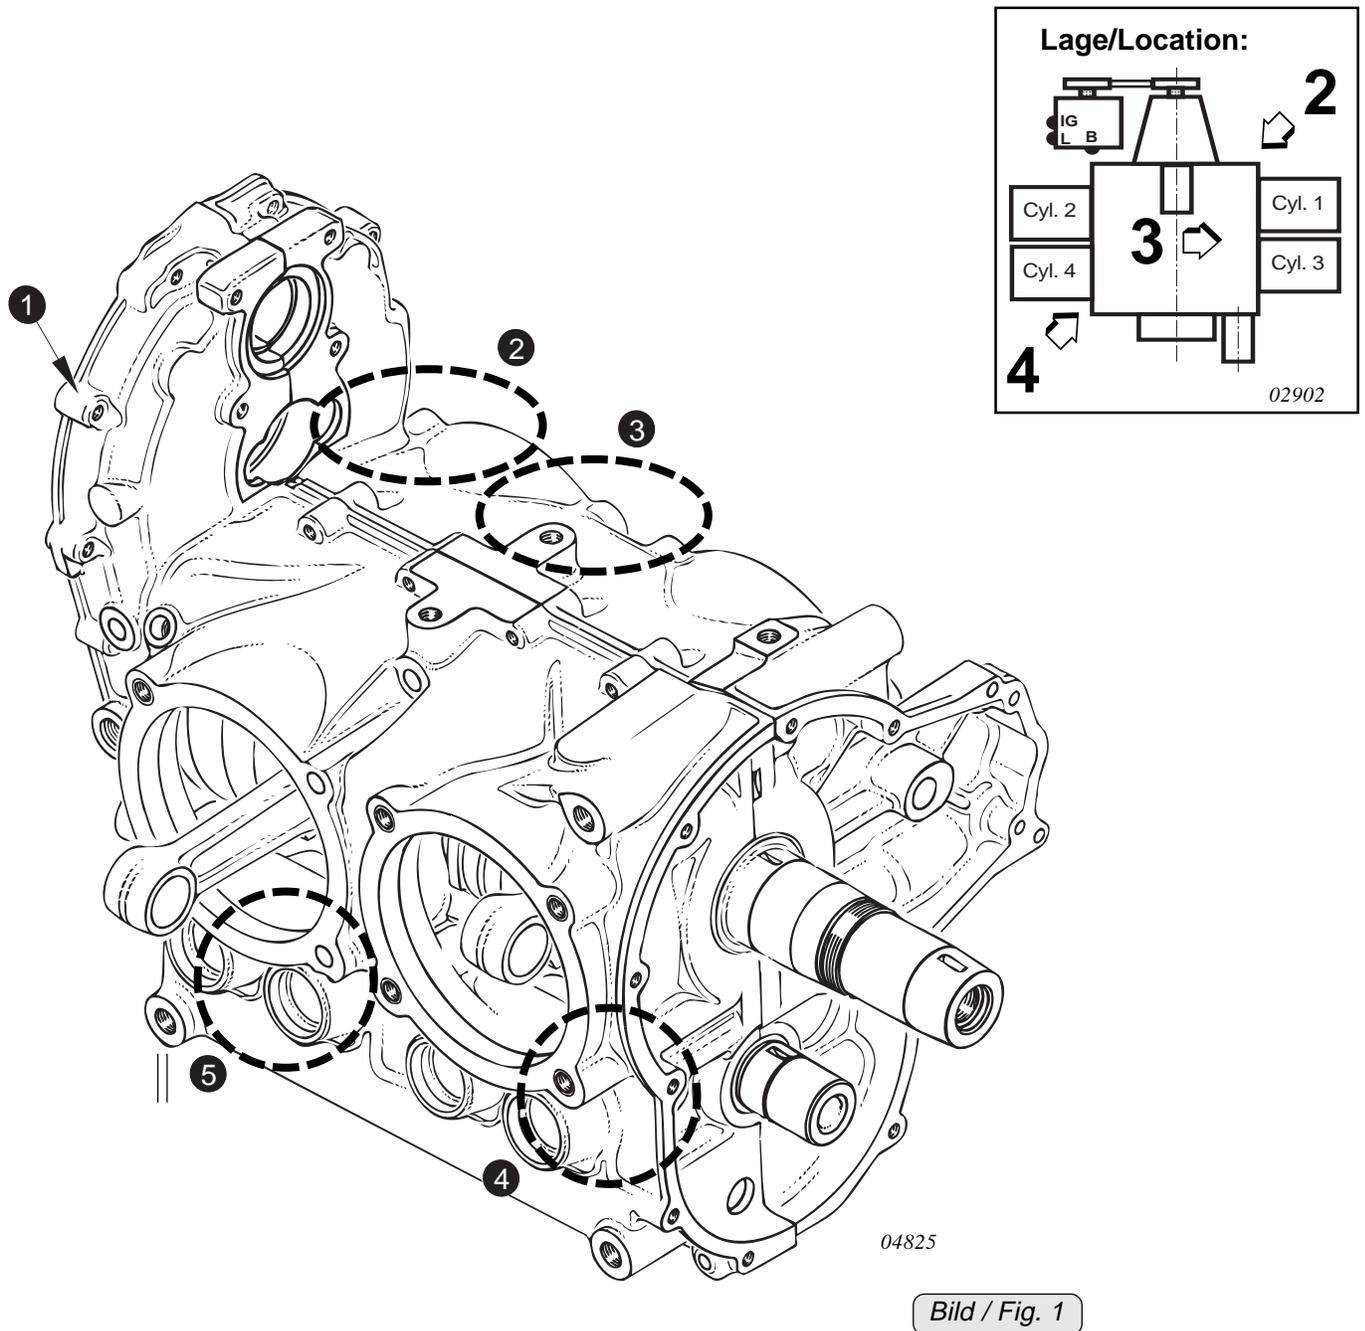
Bild / Fig. 1

- Visually inspect the crankcase (1) and engine suspension for cracks in accordance with the relevant Maintenance Manual.

◆ **NOTE:** Scrutinize the crankcase for cracks especially in the area of cylinder 1 upper side (2), between cylinder 1 and 3 upper side (3), cylinder 4 lower side (4) and between the hydraulic valve tappet hole (5) of cylinder 2. See fig. 1.

For those engines using the ROTAX[®] cooling air baffle. Visually inspect for oil leaks in area (2) and (3). If leaks are found, then further investigation to determine the cause of the oil leak is required. If the exact origin of the leak can not be determined i.e. governor, then removal of the cooling air baffle may be required.

- If cracks are detected the nearest ROTAX[®] Authorized Distributor (see also our official ROTAX-Web-Site: www.rotax-aircraft-engines.com) has to be informed and if necessary the engine has to be removed from aircraft and must be returned to a ROTAX[®] Authorized Distributor.
- Reconnect negative terminal of aircraft battery (after installation of engine).
